High resolution structural inspection of flooded tunnel using BlueView T2250 360° Multibeam Profiling Sonar and Teledyne PDS

Päijänne water tunnel

May 2016

Lake Päijänne,
Southern Finland

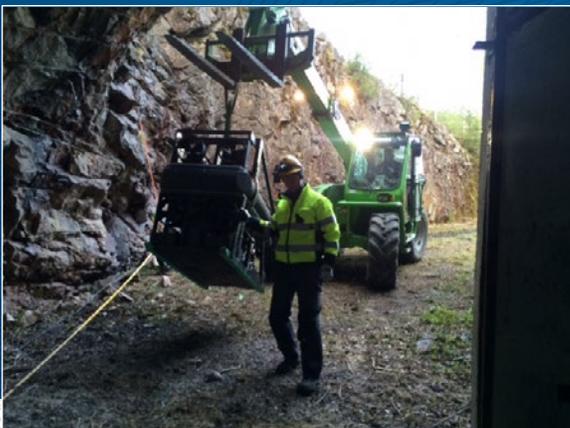
The ROV is driven down access shaft to the entry point of flooded tunnel

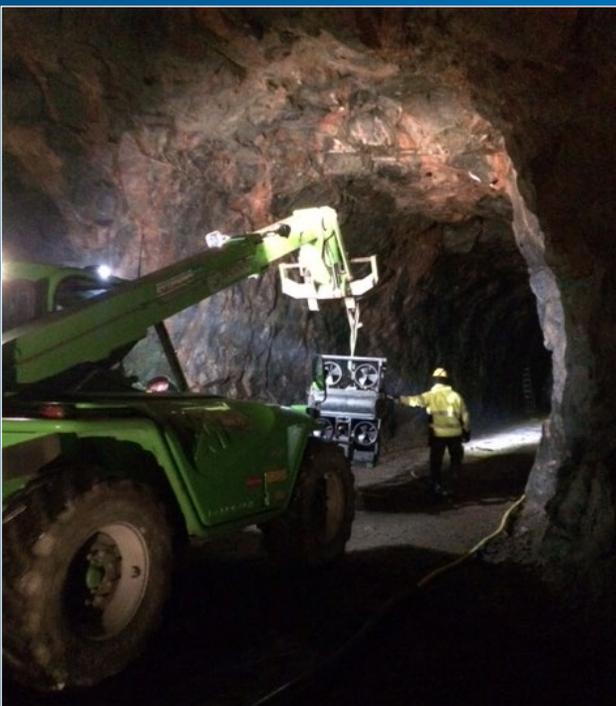
ROV transportation to deployment area inside the tunnel

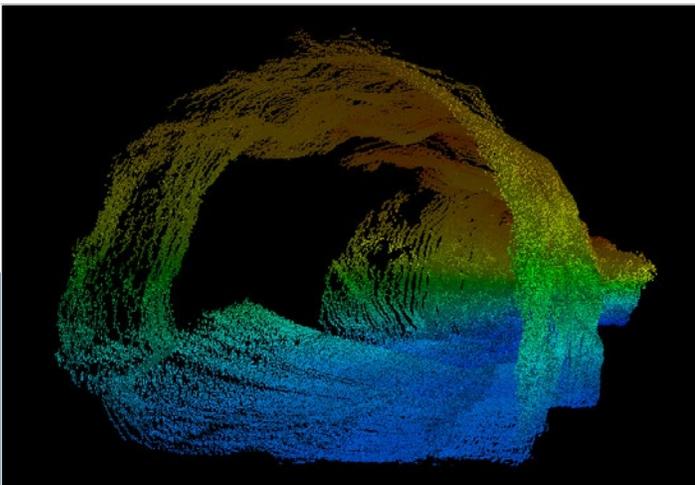
3D profile data image showing the solid integrity of the tunnel

The tunnel was inspected without dewatering. A dense high resolution point cloud was created allowing engineers to take accurate measurements in all three planes from which an assessment of structural integrity could be made. Even loose rocks as small as 20-30 centimeters in length were quickly identified in the model (previously such targets might only have been found by trawling through hours of video records).

The quality of previous repair work was assured and structural integrity was shown to be sound at the time of inspection allowing the client to maintain their routine operations. Water flow could even be increased without damaging the tunnel.

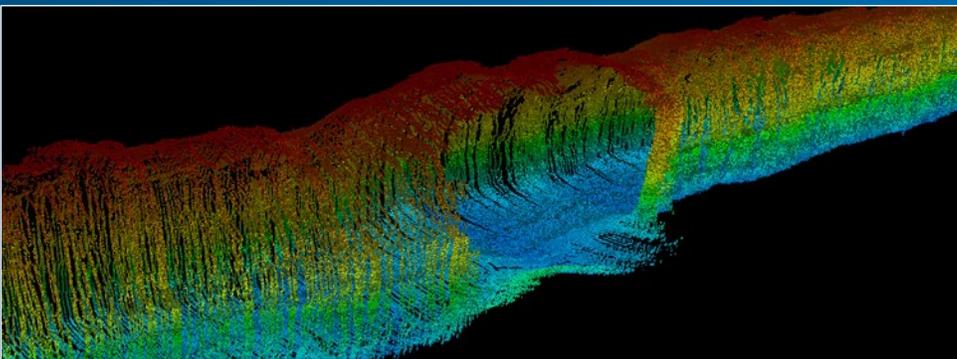
3D profile data image showing the solid integrity of the tunnel

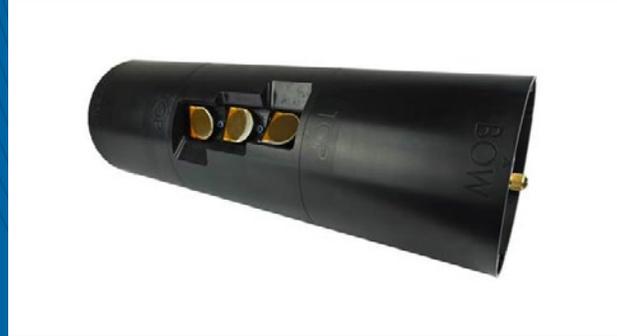
BlueView T2250 multibeam profiling sonar

Enter BlueView's T2250 multibeam profiling sonar, a compact turnkey system specifically designed to produce high density 3D data to centimetric accuracy. Utilizing high frequency, low power acoustic multibeam technology, the system uses 2100 overlapping narrow beams to create a continuous 360° profile which is streamed to Teledyne PDS software at a frequency of over 20Hz creating a dense 3D point cloud from which a truly detailed analysis of the health of a structure can be made. Designed for use on ROVs but with a built in data logger making AUV deployment equally straight forward, the T2250 allows inspection companies to use existing ROV technologies to map tunnels in fine detail without the risks associated with dewatering. One such company, Loxus Technologies of Finland put their new 360 degree multibeam profiler to the test...

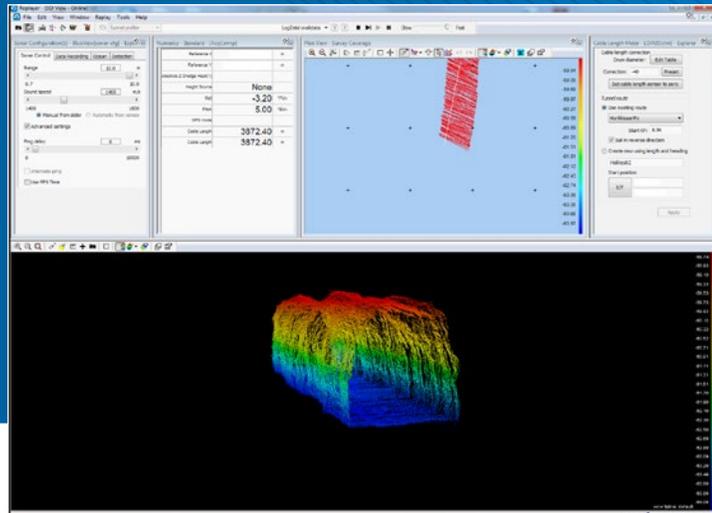
360° tunnel inspection data

The 3D data set was detailed and comprehensive thanks to the high update rate, beam density and spatial resolution of the T2250 360 degree multibeam profiler. The use of the multibeam profiler gave considerably more information on the tunnel's characteristics than single beam scanning sonars might have in the past and also made for faster data acquisition. Its small size allowed it to be integrated on an existing underwater inspection vehicle. Profiler measurements were displayed and recorded in real time, aiding piloting of the ROV while providing a permanent 3D data set for subsequent analysis. Teledyne PDS was used for 3D online visualization combined with several utility views to aid the ROV operator. Offline analysis has been done using PDS Processing utilizing the 3D editing possibilities that PDS provides.
